Use Attainability Analysis  
for  
WBID 1337 Little Clear Creek  
Submitted by  
SES, Inc.  
To  
Missouri Department of Natural Resources  
Water Protection Program  
Date Received: June 4, 2007

**Field Data Sheets for Recreation Use Stream Surveys**  
**Data Sheet A - Water Body Identification**  
(For water body being surveyed)

Water Body Name:	Little Clear Creek	WBID:	1337
8 digit HUC code:	10290105	County:	Vernon
Upstream Legal Description	34N 30W 8		
Downstream Legal Description	34N 30W 9		
Number of Sites Evaluated	3		
List all site numbers, listed upstream to downstream	1,2,3

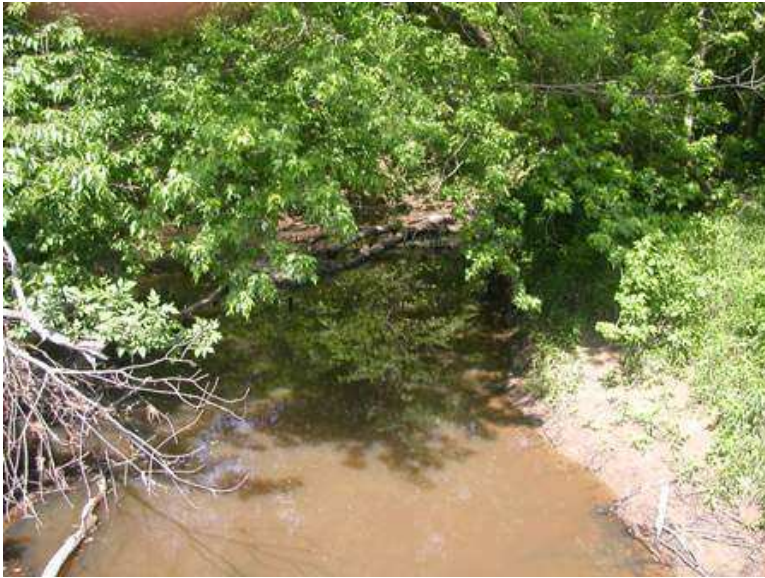
**Site# 1 Photo ID# 117, Upstream**

**WBID #** 1337      **Site #** 1  
**Mark #** 60      **Dissolved Oxygen (ppm)** 11.6  
**Upstream Views Physical Dimensions:** Is there any water present at this view? yes  
 If so, is there an obvious current? yes

% of Channel Feature				
Riffle	15				
Run	0				
Pool	85

% Cobble	% Gravel	% Sand	% Silt
15	20	0	30
% Mud/Clay	% Bedrock		
35	0

Water grasses. Not much vegetation along banks. No floating algae. Algae on rocks.

Odor      Sewage    Musky    Chemical    **None**    Other  
 Color      **Clear**      Green    Gray      Milky    Other  
 Bottom Deposit    Sludge    Solids    Fine Sed.    None    **Other: leaves**  
 Surface Deposit    Oil      **Scum: in 1**    Foam    **None**    Other

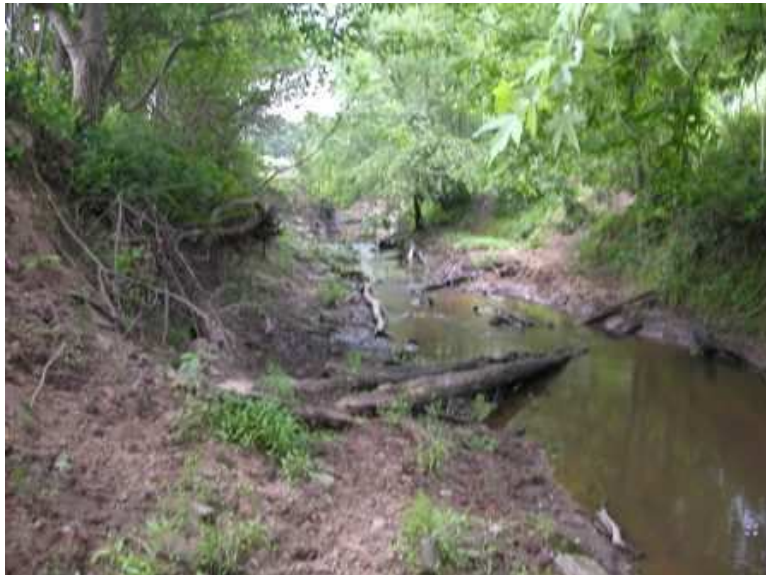
**Site# 2 Photo ID# 118, Upstream**

**WBID #** 1337      **Site #** 2  
**Mark #** 61      **Dissolved Oxygen (ppm)** 11  
**Upstream Views Physical Dimensions:** Is there any water present at this view? yes  
 If so, is there an obvious current? yes

% of Channel Feature				
Riffle	0				
Run	0				
Pool	100

% Cobble	% Gravel	% Sand	% Silt
12	4	0	42
% Mud/Clay	% Bedrock		
42	0

No floating algae. Little vegetation along banks. Algae on bottom.

Odor	Sewage	Musky	Chemical	<b>None</b>	Other
Color	<b>Clear</b>	Green	Gray	Milky	Other
Bottom Deposit	Sludge	Solids	Fine Sed.	None	<b>Other: leaves, detritus</b>
Surface Deposit	Oil	Scum	Foam	<b>None</b>	Other

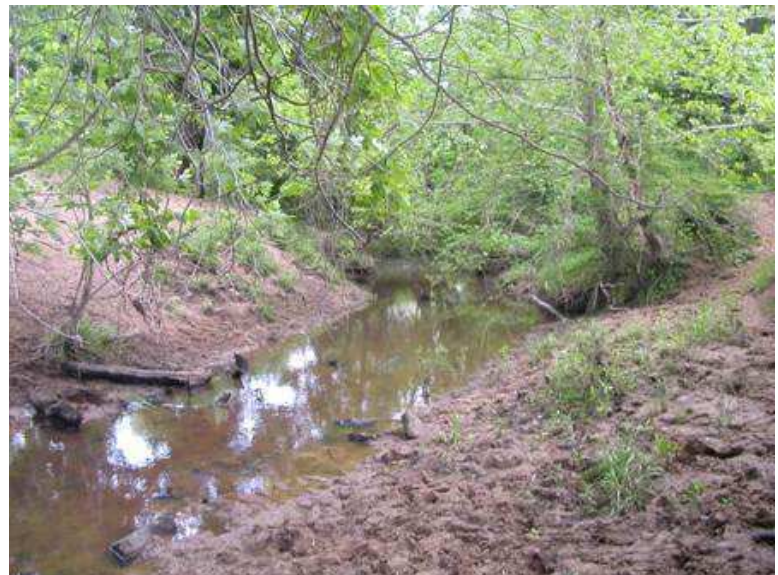
**Site# 2 Photo ID# 119, Downstream / livestock watering**

Roads	Rope swings	Foot paths/prints	Dock/platform
<b>Livestock Watering</b> <b>See Picture 119</b>	RV/ATV Tracks	Camping Sites	Fire pit/ring
NPDES Discharge	Fishing Tackle	Other:

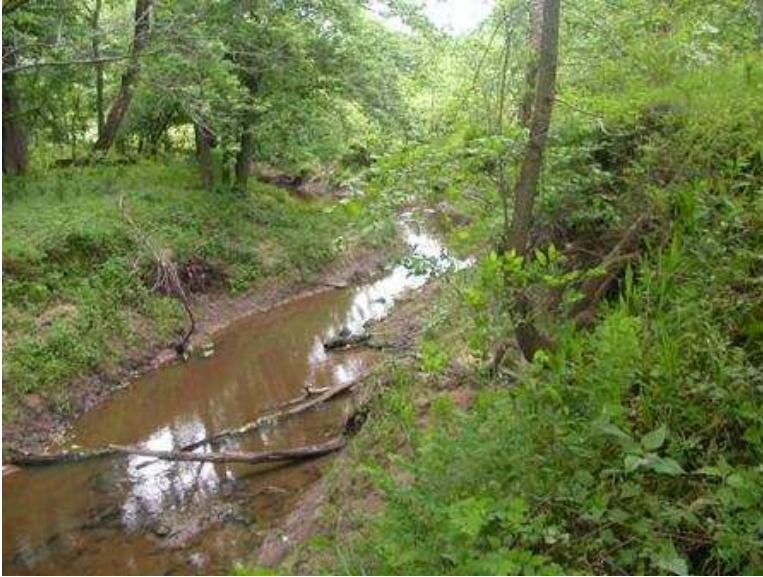
**Site# 3 Photo ID# 121, Upstream**

**WBID #** 1337      **Site #** 3  
**Mark #** 62      **Dissolved Oxygen (ppm)** 11.1  
**Upstream Views Physical Dimensions:** Is there any water present at this view?      yes

% of Channel Feature				
Riffle	0				
Run	0				
Pool	100

% Cobble	% Gravel	% Sand	% Silt
5	0	0	45
% Mud/Clay	% Bedrock		
50	0

Some water grasses. No floating algae. Little vegetation along banks.

Odor	Sewage	Musky	Chemical	<b>None</b>	Other
Color	<b>Clear</b>	Green	Gray	Milky	Other
Bottom Deposit	Sludge	Solids	Fine Sed.	<b>None</b>	Other
Surface Deposit	Oil	Scum	Foam	<b>None</b>	Other
